Health Science Building Audit

By: Ava Bebbington & Manav Shah | Supervisors: Prof. Gunay &
Prof. O'Brien

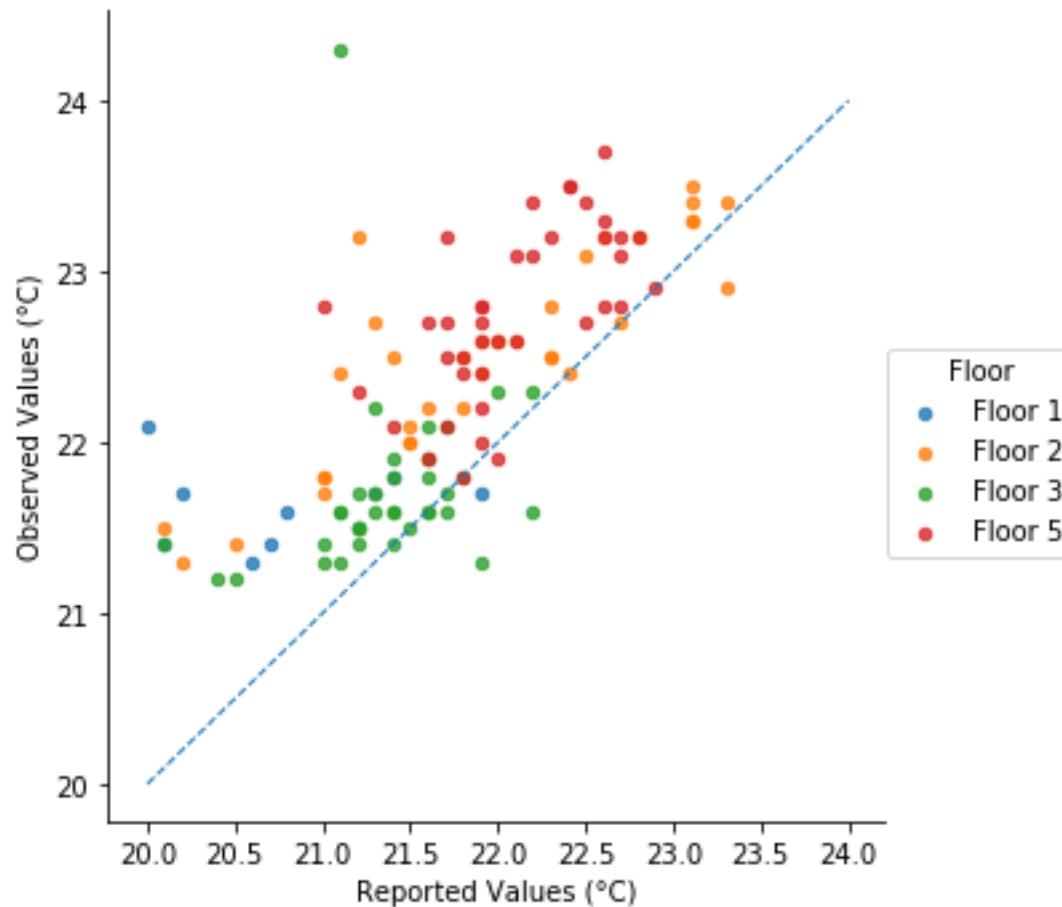
- Mean Absolute Bias: 0.657°C

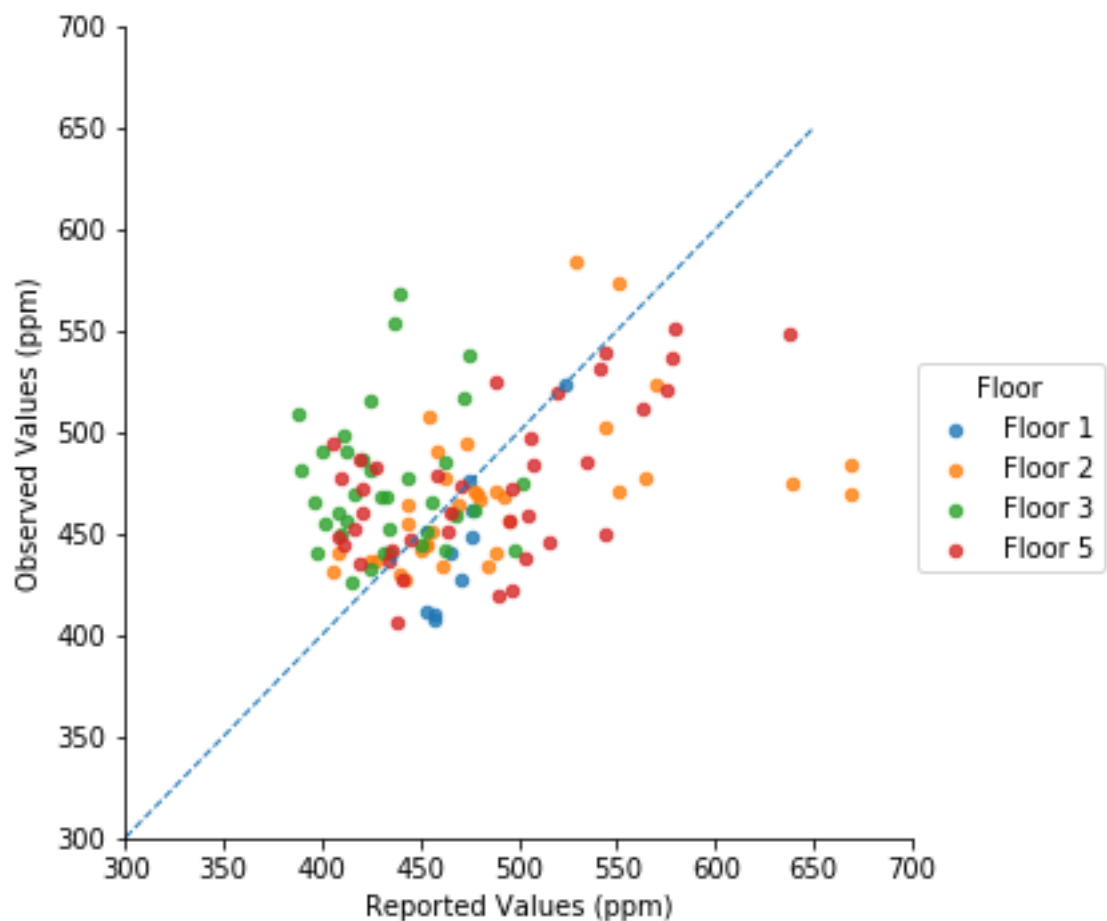
- Mean Absolute Bias: 38.2 ppm

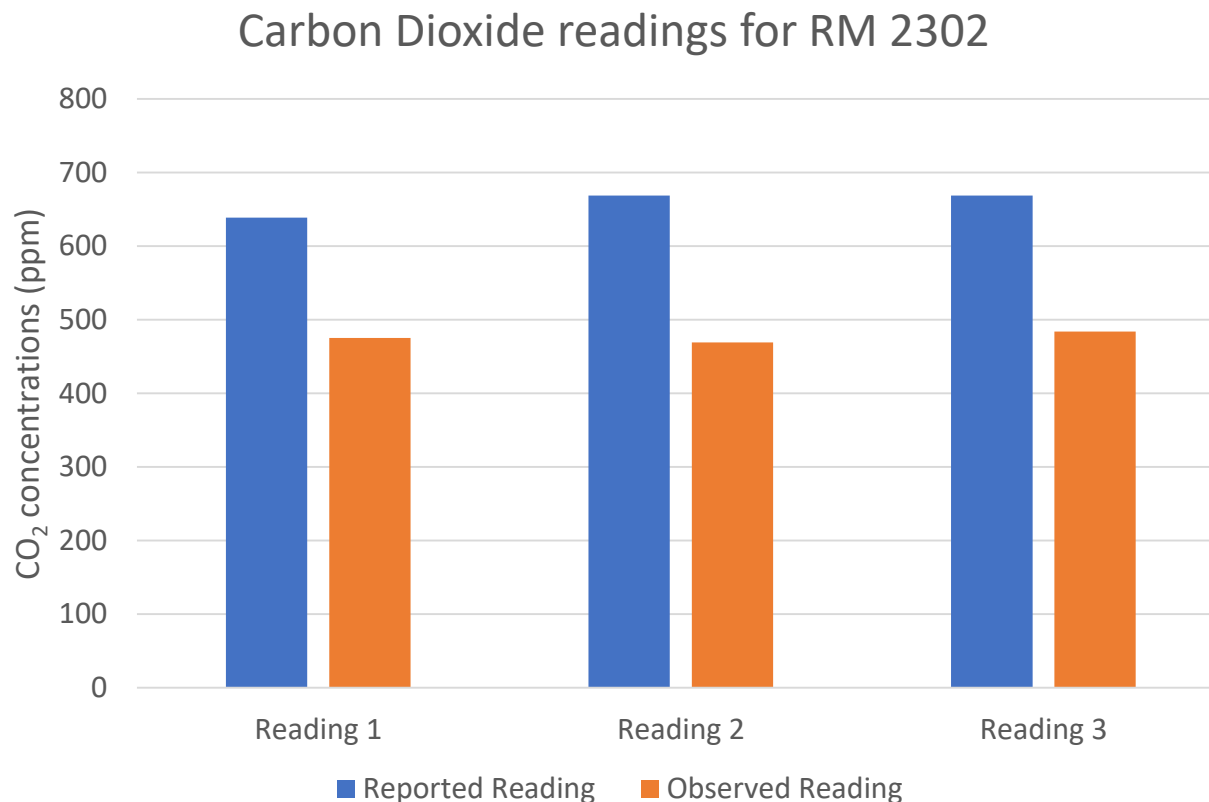
Anomaly: Room 2302

- Larger bias: reported values 183 ppm higher

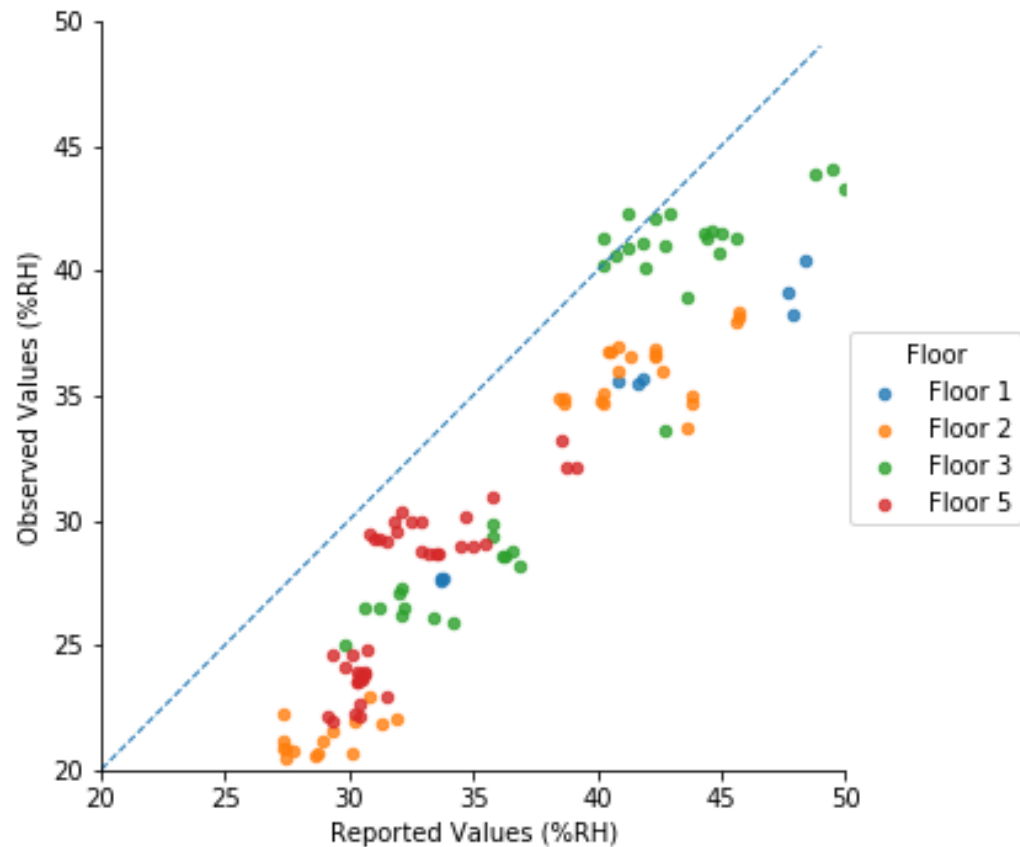
- Mean Absolute Bias: 5.74%RH
- Consistent bias across rooms

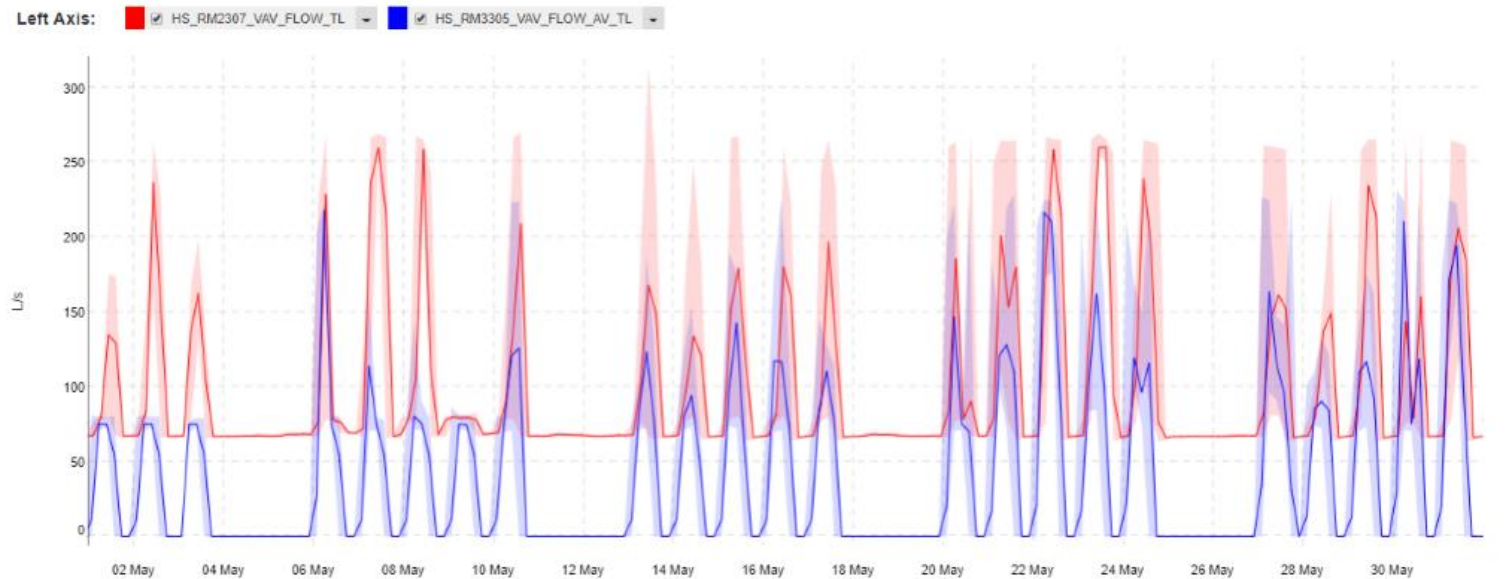
Key Issue

- Reported flow when VAV dampers are closed.
- No flow observed by capture hood, but enteliWEB reports non-zero flow.
- Reported flow ranged from 30 – 80 L/s

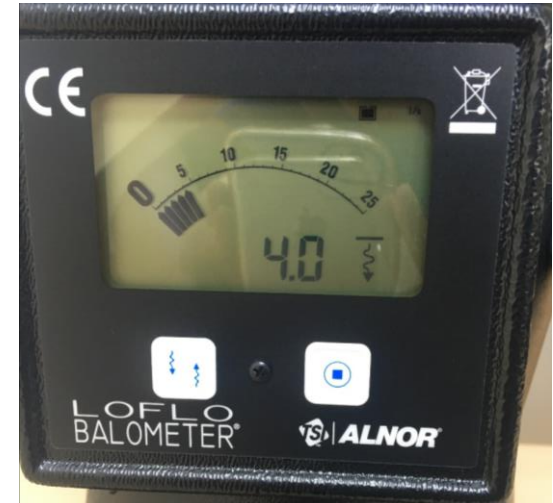
Key Issue #2: Leaky Dampers

- Observed flow when dampers are closed.
- Dampers are not fully closing.
- Only affects two rooms, leaking 4.0 – 6.5 L/s.
- For comparison, this issue affected all rooms in Canal, and amount of air leaking went upwards of 100 L/s in some cases.

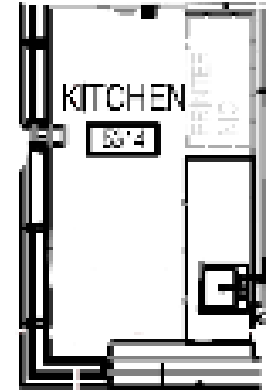
Anomaly: Room 5314

- Fifth Floor Kitchen
- Measured flow was $\sim 1.8x$ higher than the reported flow.

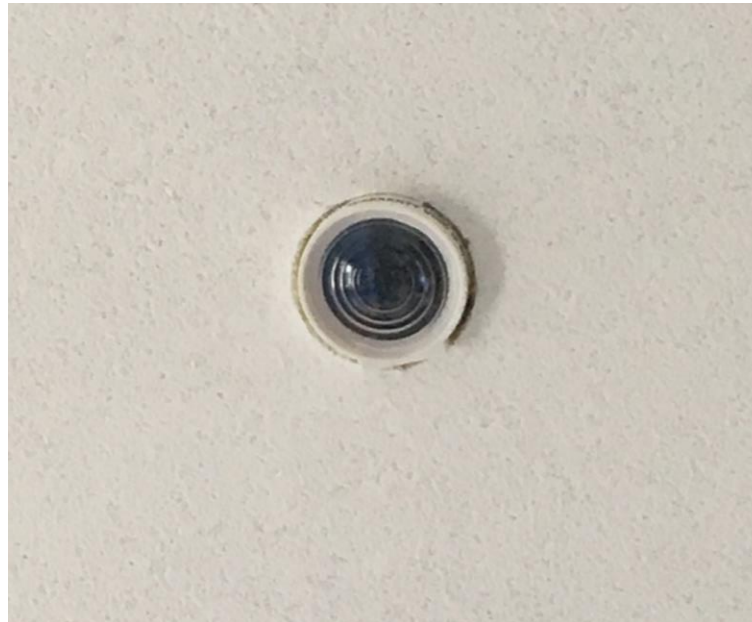
- Difficulty in finding exact bias due to light changes from windows, lux meter obstructing sensor, etc
- Approximate bias: 27.5 lux
- Very large variance, observed from 3 lux - 819 lux

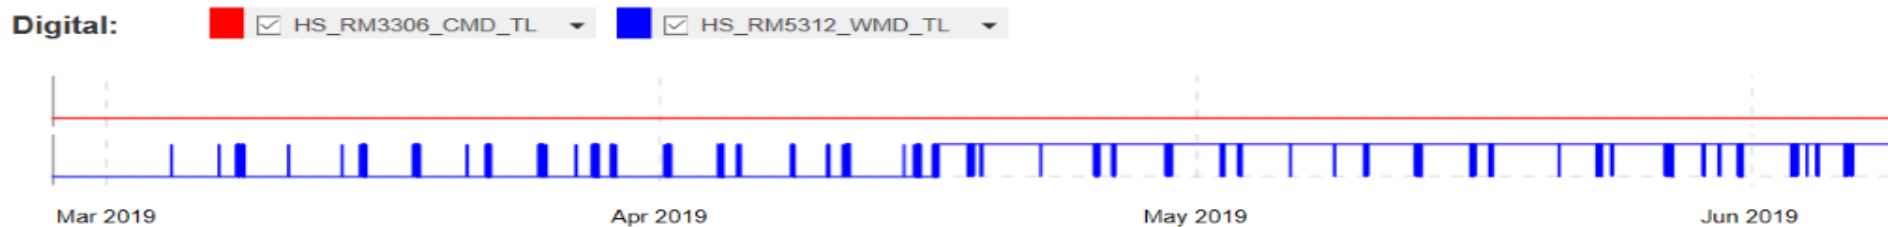
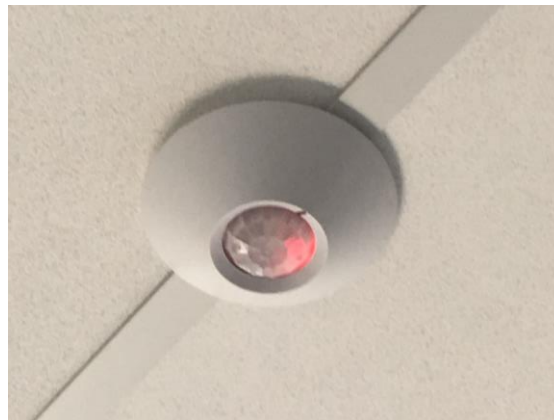
- Broken window contact sensors: Rooms 5305, 5307, 5310, 5313
- Broken motion detectors: WMD in 5312, CMD in 3306
