Carleton University
Joint Health and Safety Committee - Workplace Inspection Report

Building:	Loeb Building	Inspected	Ali Ghaharbeighi & Cheryl Murphy
Area Inspected:	Tower A	Tel:	X 4577
Date:	August 4, 2021	Email:	Ali.Ghaharbeighi@carleton.ca/Cheryl.Murphy@carleton.ca

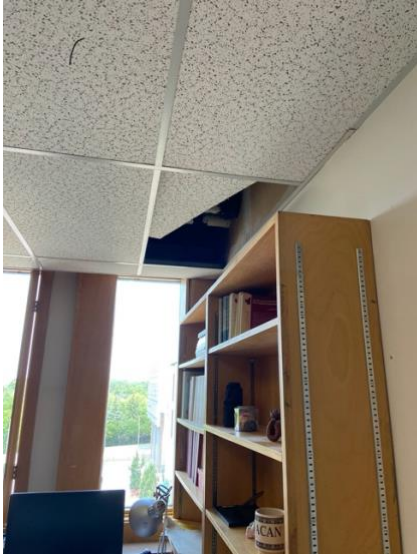
SSAC	A830	Room not inspected – key pad on door				
SSAC	A832	Room not inspected – key pad on door				
SSAC	A804	Missing ceiling tile – risk of debris falling onto occupant (see photo)	Replace missing/damaged tile	replaced	Sept 14/21	CL
Soc/Anth	A735	Room not inspected – key did not work in door		LPC – special keys required; happy to provide access.		PW
Soc/Anth	A735A	Room not inspected – key did not work in door		LPC – same as above		PW
Soc/Anth	A712	Room not inspected – swipe card reader		Kitchenette – happy to provide access		PW
Soc/Anth	A739	Ceiling tile falling/sagging – risk of falling onto occupant (see photo)	Replace missing/damaged tile	Fixed placement of tiles	Aug 25,21	BC

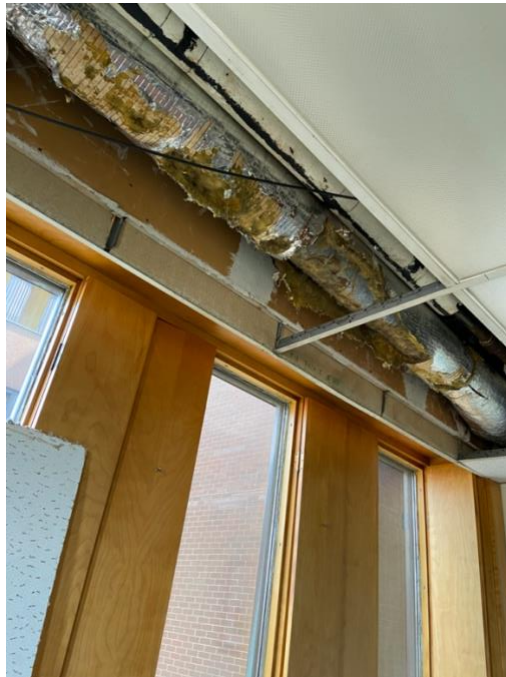
Psychology	A531	Room not inspected – key did not work in door	Available for inspection at your convenience			
Psychology	A507	Missing ceiling tile – exposed deteriorated wrapped duct work - risk of debris falling onto occupant (see photo)	Replace missing/damaged tiles	relaced	Sept 10/21	CL
DGES	A410	Room not inspected – swipe card reader on door				
DGES	A410A	Room not inspected – no access				
ITS-Admin	A410B	Room not inspected – no access				
DGES	A409	Room not inspected – key not working in door				
DGES	A427	Room not inspected – no access				
DGES	A427A	Room not inspected – no access				
DGES	A427B	Room not inspected – no access				
DGES	A427C	Room not inspected – no access				
DGES	A427D	Room not inspected – no access				
DGES	A427E	Room not inspected – no access				
Psychology	A431	Room not inspected – swipe card reader on door	Not Psychology's

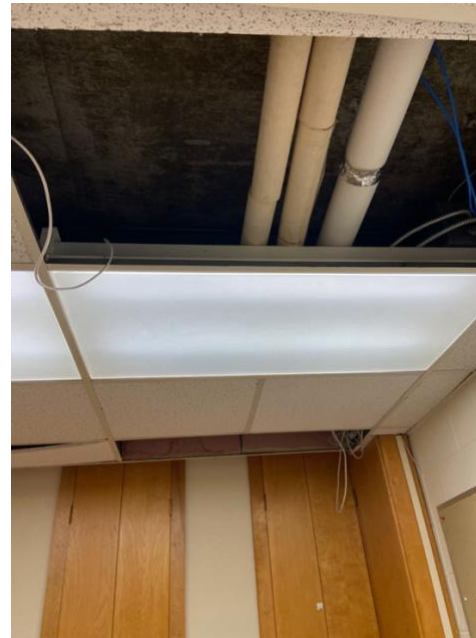
Psychology	A402	Missing ceiling tile – exposed duct work – risk of debris falling onto occupant (see photo)	Replace missing/damaged tiles	replaced	Sept 13/21	CL
Psychology	A401	Missing ceiling tile – exposed deteriorated wrapped duct work – risk of debris falling onto occupant (see photo)	Replace missing/damaged tiles	replaced	Sept 13/21	CL
Psychology	A407	Missing ceiling tile – risk of debris falling onto occupant (see photos)	Replace missing/damaged tile	replaced	Sept 13/21	CL
DGES	A302	Room not inspected – no access – swipe card reader on door				
DGES	A303	Room not inspected – no access – swipe card reader on door				
DGES	A301E	Missing ceiling tile – exposed ductwork and dangling cables – risk to room occupant of falling debris and tangle (see photo)	Replace missing/damaged tile	replaced	Sept 13/21	CL
DGES	A301B	Dangling light cover – risk of falling onto room occupant (see photo)	Secure light cover

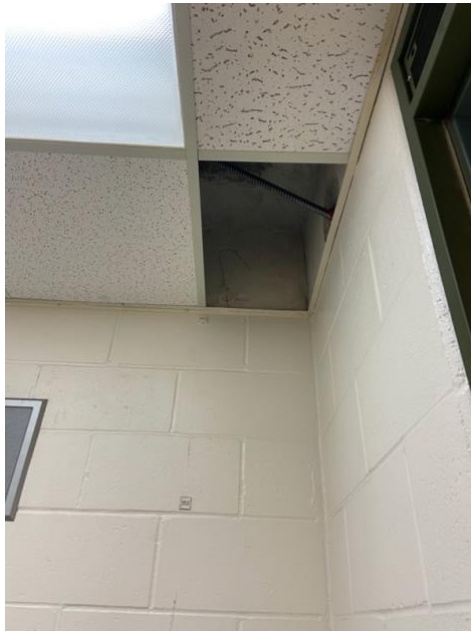
DGES	A312	Missing ceiling tile – risk of falling debris (see photo)	Replace missing/damaged tile	replaced	Sept 13/21	CL
DGES	A317	Room not inspected – key did not open door				
DGES	A323	Room not inspected – no access – swipe card reader on door				
DGES	A333	Room not inspected – no access – swipe card reader on door				
Psychology	A322	Damaged lock	Replace lock			
DGES	A327	Missing ceiling tile – risk of falling debris (see photo)	Replace missing/damaged tile	Replaced	Sept 14/21	CL
DGES	A200	Room not inspected – no access				
Scheduling	A204	Room not inspected – no access				
DGES	A211	Room not inspected – no access				
DGES	A211A	Room not inspected – no access				
DGES	A220	Room not inspected – no access				
DGES	A220A	Room not inspected – no access				
DGES	A237	Room not inspected – no access
