The Church of Santiago de Kuño Tambo

**Jesslyn Granda – BA Candidate, Carleton University Azrieli School of Architecture and Urbanism
and Crystal Hanley – Research Assistant, Carleton Immersive Media Studio**

***Abstract:** In this paper we will discuss the collaboration between the Carleton Immersive Media Studio and the Getty Conservation Institute for their Earthen Architecture Initiative's - Seismic Retrofitting Project. Identified as a prototype building for this project, the Church of Santiago de Kuño Tambo, Peru was selected.*

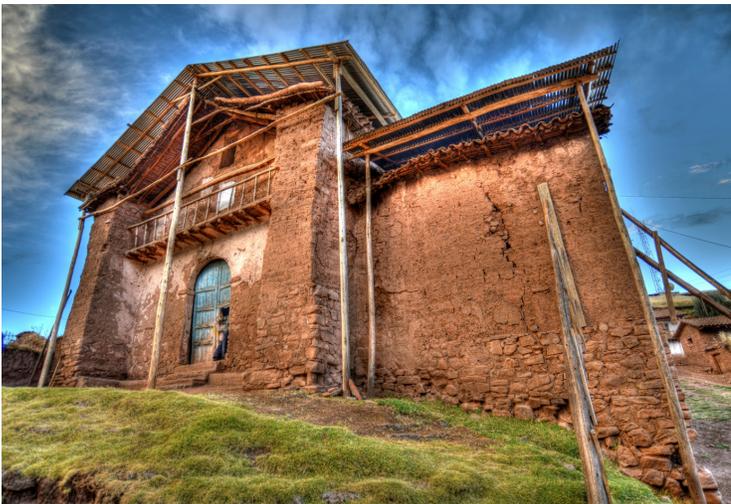
Santana-Quintero, Mario. *The Church of Santiago de Kuño Tambo*. June, 2013. Carleton Immersive Media Studio.

Designated as a national historic site in Peru, the Church of Santiago de Kuño Tambo has never been restored. It is vulnerable to seismic damage due to its location and has already incurred significant water damage caused by a leaking roof, compromised or complete loss of structural elements, and settlement

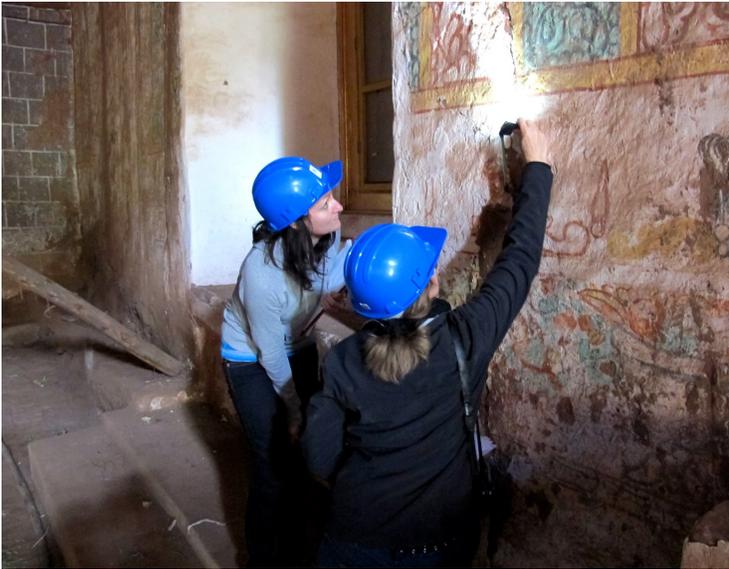
Crystal Hanley (Carleton Immersive Media Studio) and Leslie Rainer (The Getty Conservation Institute) analyze the 17th century wall paintings of the Church of Santiago de Kuño Tambo. [Santana-Quintero, Mario. January, 2013. Carleton Immersive Media Studio].

The walls were analyzed, and eighteen deterioration conditions were identified and categorized as either structural, plaster, paint, surface conditions, or previous interventions – all of which significantly affect the original wall paintings.

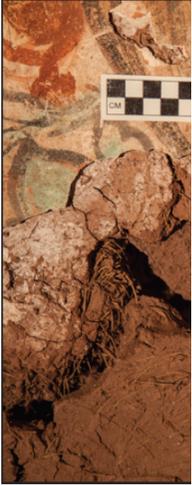
Hanley, Crystal. *Condition Assessment (Structural cracks)*. August, 2013. Property of the Getty Conservation Institute.

| CONDITION STRUCTURAL | | |
|--|---|---|
| CAD | STRUCTURAL CRACKS Fissure that extends into the earthen wall support, to a depth of at least one adobe | |
| HAND DRAWN | GRIETA ESTRUCTURAL Fisura que se extiende dentro del muro de soporte en tierra a una profundidad de al menos un adobe | |

OCCURENCE IN CHURCH
 Sector D
 West Wall
 Photo: _MG_6132.CR2

Graphic symbols were then created using the limited palette of available overhead transparency markers in the region - red, blue, green and black, and to correspond to the definitions derived from the visual glossary. These symbols (both digitally and manually generated) were essential to the subsequent phase of the project to thoroughly map the deterioration conditions of the interior wall surface in its entirety.

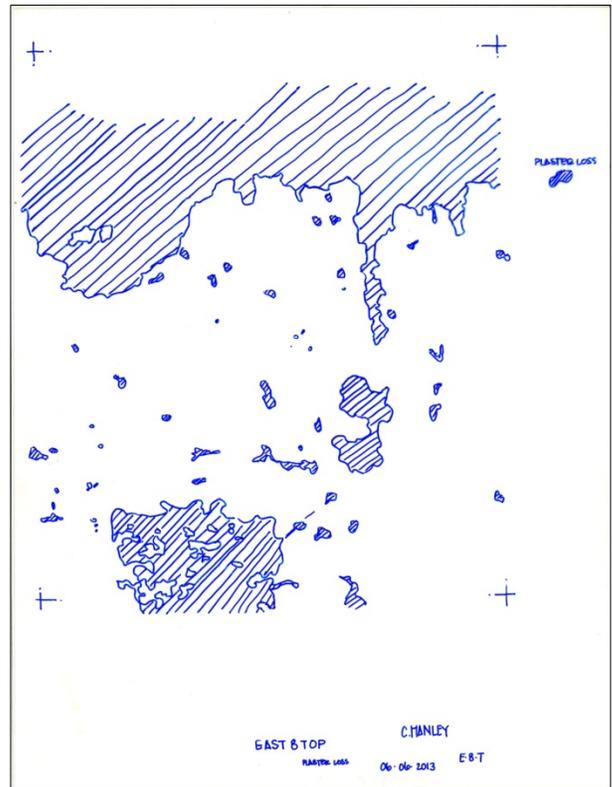
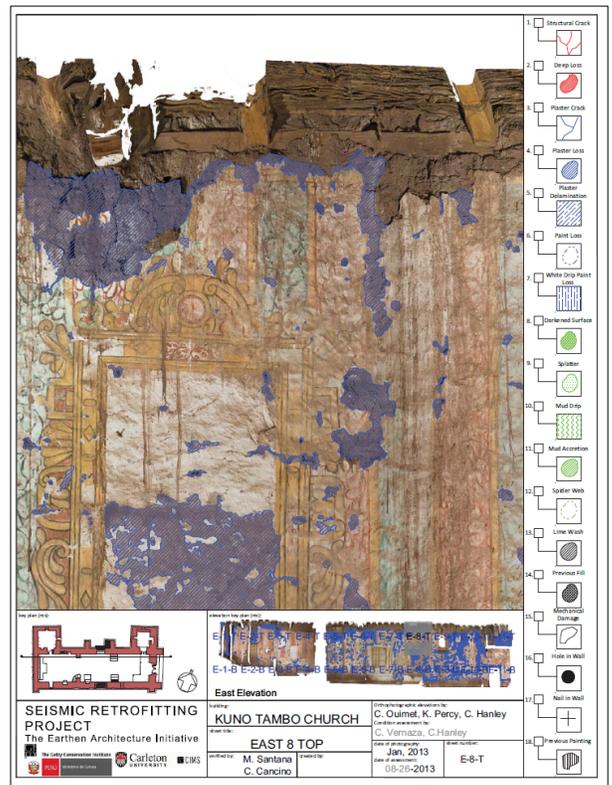
Example of “Plaster Loss” Section East-8-Top - Church of

Santiago de Kuño Tambo condition assessment..August, 2013.
Property of the Getty Conservation Institute.

On-site, each section of the wall painting surfaces was meticulously analyzed. The transparency sheets were overlaid on the images to allow for each of the eighteen conditions to be traced.

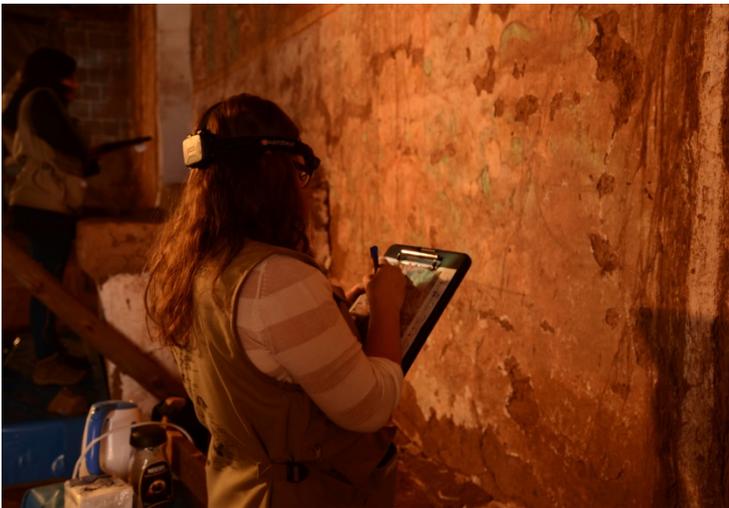
Santana-Quintero, Mario. *Wall painting condition assessment field work*. June, 2013. Carleton Immersive Media Studio

Working on-site had apparent limitations to the work. While it was initially anticipated that work could be carried out in part using a PC tablet computer, it was soon realized that it did not provide an efficient work flow. Documenting the conditions by hand proved to be far more efficient and manageable. The on-site constraints made communication and collaboration

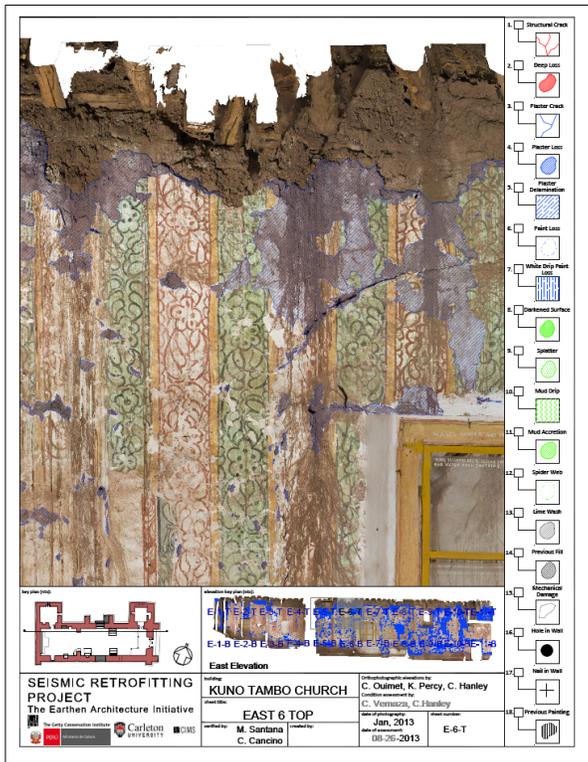
The final deliverable clearly distinguished each condition documented over the orthographic photographs for each section of each wall.

Separate AutoCAD files were created for each interior wall elevation. Each of the hand drawn assessments on transparency paper were scanned and imported into the AutoCAD files and carefully aligned to the previously created orthographic photographs. Individual layers were created within each file to correspond to each condition. The scanned images were meticulously digitally traced in AutoCAD using various line weights to clearly distinguish different deterioration conditions.
