# Monitoring permafrost conditions along the Dempster Highway

GEOQuébec  
2015

M. Idrees

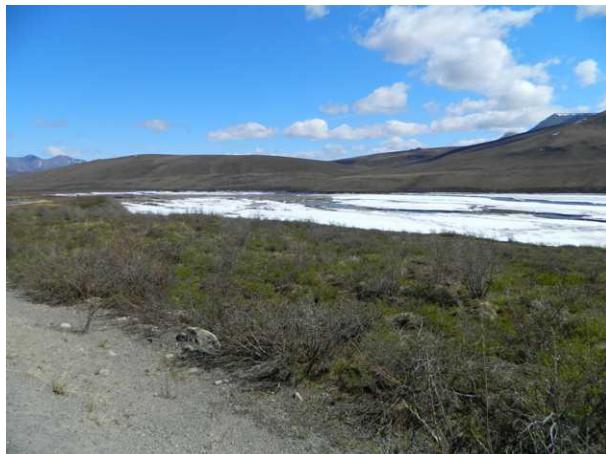
Figure 2. Blackstone River near Chapman Lake, showing extensive river icing, May 2014.

from km 85 to 130, and in other tundra areas. Icings are common in the discontinuous permafrost section. Extensive sheets of river icing develop in the Blackstone and North Klondike river channels (Figure 2) (Hu and Pollard 1997).

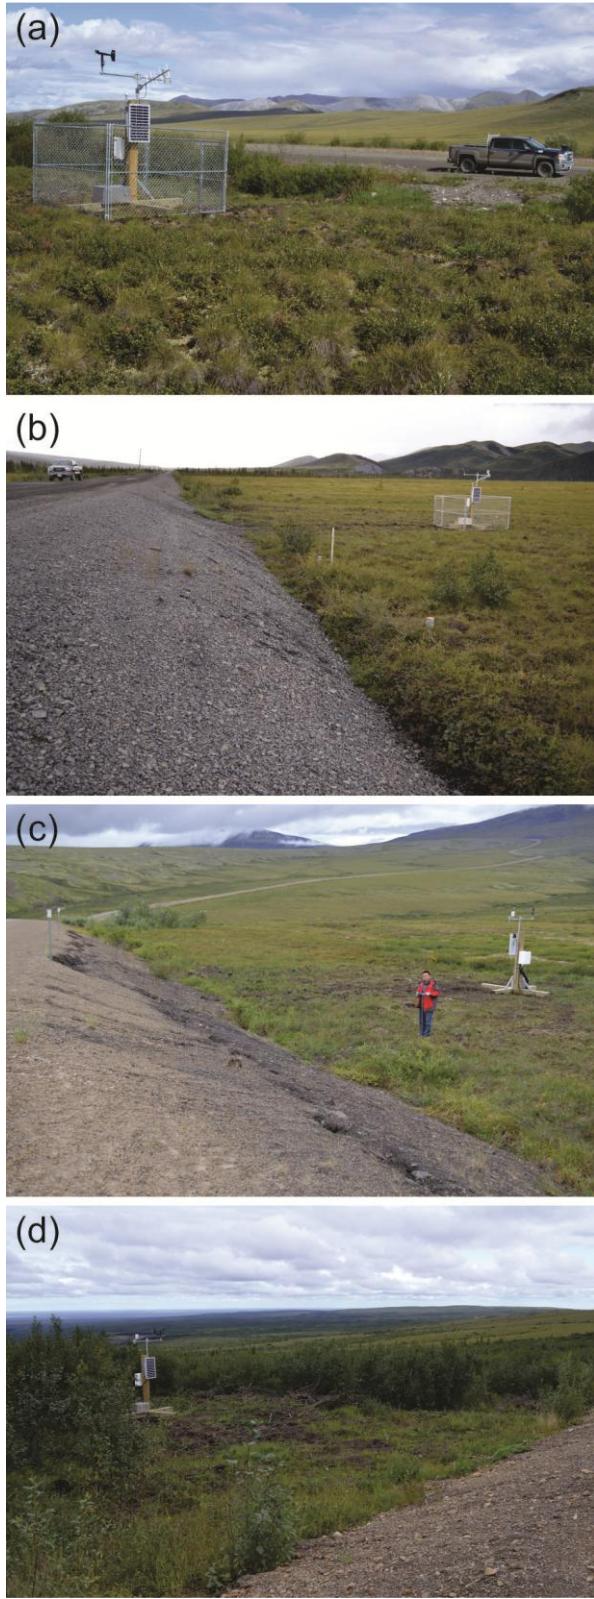
Figure 3. Permafrost monitoring sites along the Dempster Highway, late July 2014. (a) Chapman Lake airstrip; (b) Glacier Creek; (c) Territorial border; (d) Midway airstrip.

km 8.5); and on Peel Plateau, 1.8 km west of the emergency airstrip near at Midway Lake (NWT km 51.5). Coordinates of the sites and brief site descriptions are given in Table 1, and photographs of the sites are presented in Figure 3.

Site 1 is in the northernmost portion of the Blackstone Uplands, where the road follows the broad Blackstone River valley (Figure 3a). The site is north of the glacial limit (Beierle 2002). A gravel pit 1 km south of the airstrip indicates the surficial materials are mostly glaciofluvial outwash, covered by a veneer of silt. The site has well developed networks of ice-wedge polygons. These are outlined at the ground surface by slight depressions in the moss and lichen surface vegetation. Numerous willow bushes have grown adjacent to the road at the toe of the embankment. In 2005-2010, ground temperatures were measured with HOBO H-008 miniature data loggers and TMC6-HA sensors at three locations in this flat valley floor, about 500 m from the site.  $T_p$  at 1-m depth at the three sites were -4.7, -4.5, and -5.0 °C (Burn et al. 2015). The glaciofluvial terrace surface at the site is about 30 m above the Blackstone River, which flows north, subparallel to the road, about 200 m to the east.

Site 2 is 15 km north of the Arctic Circle crossing, at the foot of the western escarpment of Richardson Mountains (Figure 3b). The road runs across the slope at the site. The vegetation cover is dominated by mosses and lichens, with few bushes. The ground was not glaciated, so the gentle gradient of the lower slopes is the result of colluvial deposition continuing over millennia. Ice-wedge polygons are apparent, but their form is muted, with little development of bounding ridges and troughs.

Site 3 is on the NWT side of the territorial border (Yukon km 465) in the high Richardson Mountains (Figure 3c). It is near the location of a serious accident caused by collapse of the roadbed following thermal erosion of an ice wedge beneath the embankment. The site is on a slope descending westwards. The area is covered by dwarf birch bushes growing in mosses and lichens. The area was not glaciated, so the surficial materials are dominantly the result of colluvial processes. Bedrock exposures are visible from the road, but not at the precise location of the monitoring site. In June 2014 a large frost blister was examined on the south side of the road near the site, indicating the efficacy of water movement through the active layer at this site.

Site 4 is in Peel Plateau (Figure 3d), within the area glaciated by the Laurentide Ice Sheet. The region is underlain by extensive deposits of buried glacier ice. The rolling terrain is covered by shrub tundra, and dense alder thickets have grown alongside the highway since it was built in the 1970s (Gill et al. 2014). Tills cover much of the region (Lacelle et al. 2013). Permafrost in the Peel Plateau is remarkably warm for a tundra environment in the western Arctic (O'Neill et al. 2015a).

A weather station was erected at the field installations, 15 m from the toe of the embankment (Figure 3). This station includes Campbell Scientific HC2-S3-L air temperature and relative humidity sensors, and an anemometer and wind direction sensor (RM Young 05103AP-10-L). Data from these atmospheric sensors and the thermistors are collected by a Campbell Scientific CR1000-55 data logger via a multiplexer board (AM 16/32B XT). Weather data are stored on an hourly basis; ground temperatures are collected every four hours. As from early June 2014, data from sites 1 and 2 have been relayed by GOES satellite to a server in Whitehorse. Data are stored at sites 3 and 4 until collected.

Surface disturbance during drilling was minimal at sites 2 and 3, and moderate at site 1, where two attempts were required for completion of the installation (Figure 3). Disturbance was greatest at site 4, due to the need to clear alders and other bushes (Figure 3d).
