GEOQuébec
2015

Permafrost characterization of the Dempster Highway, Yukon and Northwest Territories

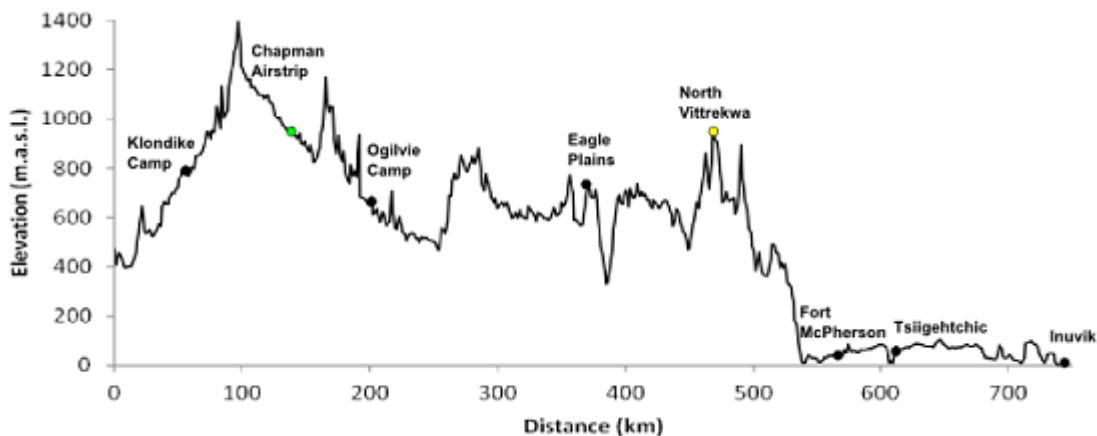
Figure 2. Schematic topographic profile for the Dempster Highway. Source: Google Earth.

For much of its length, the Dempster is a mountain highway that traverses Ogilvie and Richardson mountains of the northwestern Cordillera (Figure 2). In Ogilvie Mountains, the road follows valley floors (Figure 3), while in Richardson Mountains it crosses the ranges. The highest elevations occur in the southern sections (Figure 2). The road follows the rolling terrain of the upland Eagle Plain for about 180 km, and similarly crosses the uplands of Peel Plateau to the east of Richardson Mountains (Figure 4). From Peel River to Inuvik, the terrain is remarkably flat and at low elevation. As a result of changing elevation and latitude, the route passes through forest and tundra. Terrain units along the route are summarized in Table 1 and indicated in Figure 5.

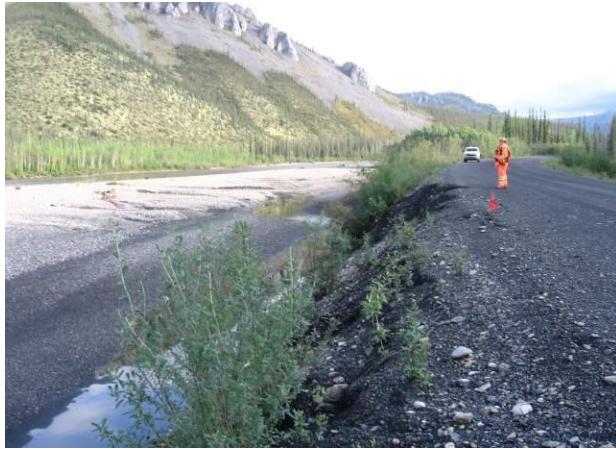
Figure 3. Dempster Highway in the valley of Ogilvie River, at km 210, August 2011. Photo by S.N. Orban.

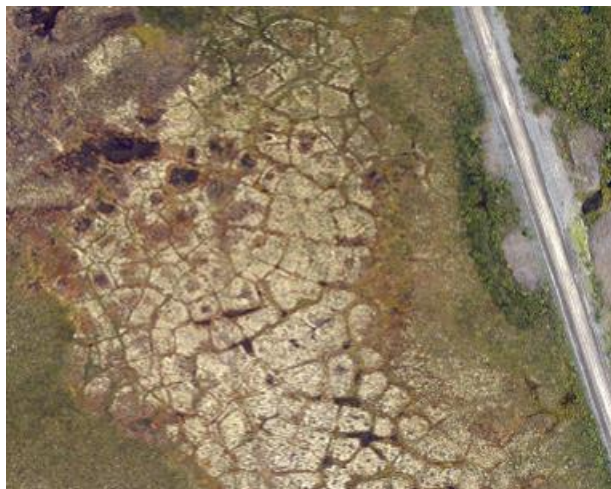
Figure 6. Ice-wedge polygons near the highway in Blackstone Uplands. Image from Google Earth.

Ice-wedge polygons may be recognized along the route in many sections, as, for example, in Figure 6. These polygons characteristically have slight depressions above the wedges, and lack the raised rims formed by actively growing ice wedges. They are most commonly seen at tundra sites. The ice wedges are of massive ice (e.g., Idrees *et al.* 2015, Fig. 6).

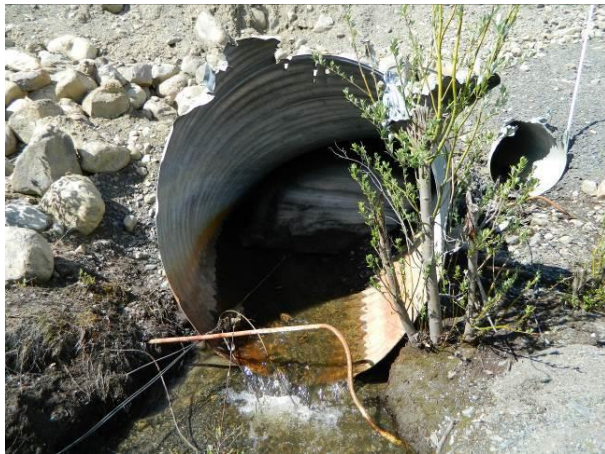
Figure 7. Culvert at km 32.5 (North Klondike River valley), filled with icing, May 2014. Photo by C.R. Burn.

The principal terrain hazard in the first 80 km of the route is development of icings that block culverts and impede drainage (Figure 7). If discharge continues through the winter, the embankment may be insufficiently high to retain the accumulating water (ice), and it may flow onto the driving surface. This is a principal hazard in winter, but in freshet, blocked culverts may lead to alternate routing of surface water and washout of the embankment.

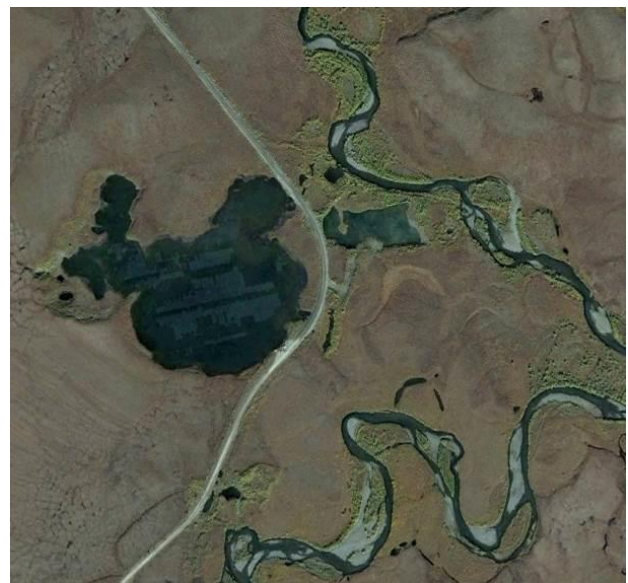
Figure 8. Thermokarst expansion of Two Moose Lake has brought it to the highway embankment. Image from Google Earth.

Two Moose Lake (km 102) is within the glacial limits in Blackstone Valley, and is surrounded by moraine. Thermokarst development of the lake has brought the shoreline to the road embankment, so that temperatures beneath the road are now affected by the lake (Figure 8). Continual maintenance has been required at this point.

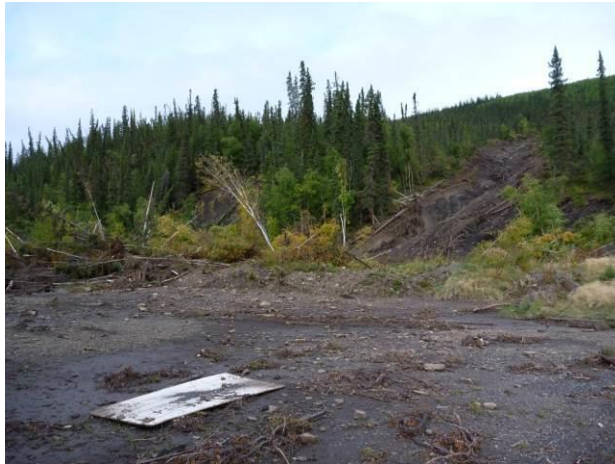
Figure 9. Debris flow at km 244, August 2010. Photo by C.R. Burn.

soil. In clastic bedrock, a surface veneer of soil rests on permafrost. During heavy rain, landslides and debris flows may block the road (Figure 9), with the occurrence facilitated by the relatively impermeable permafrost.

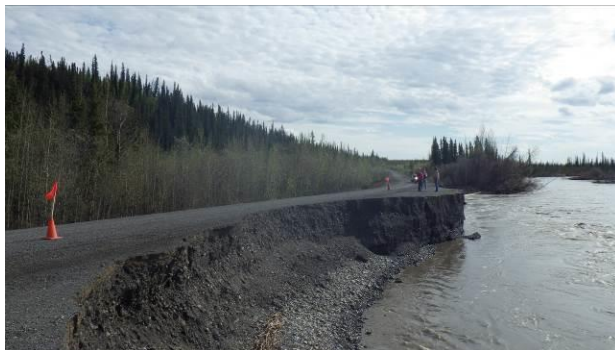
Figure 10. Wash out of the road by Ogilvie River at km 245, June 2013. Photo by S.N. Orban

High discharge and coarse bedload in the streams during freshet and following rain storms may erode the riverbank supporting the highway and bridge abutments, requiring reconstruction of the road bed (Figure 10). Drainage structures may appear to be over designed in summer for the magnitude of flow, but even these may still be damaged in the spring flood.

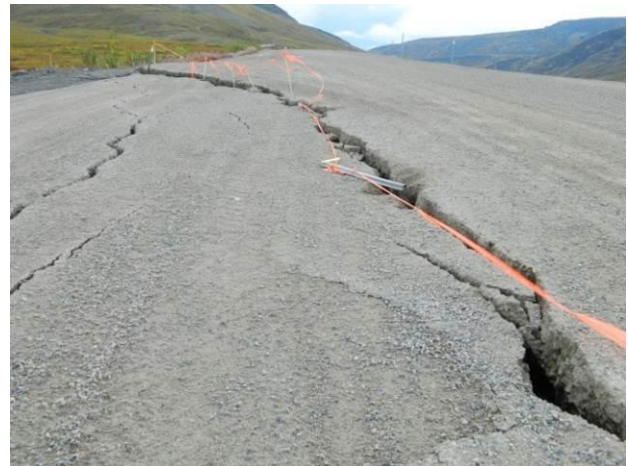
Figure 11. Thaw subsidence of the embankment at NT km 27, August 2011. Photo by C.R. Burn.

Subsidence of the embankment due to thaw of ground ice is a principal hazard in this section (Figure 11). The ground ice is localized, because the mountains were not glaciated. It may occur as ice wedges or bodies of intrusive ice. However, given the extensive time available for hill slope movement, any surface expression of the ice formation may have been covered by subsequent deposits. Figure 11 shows thaw subsidence of the road embankment at km 27. Degradation of the driving surface is generally managed through routine maintenance along the route. Shoulder rotation due to thaw settlement of the toe may be observed in several places.
